PARADISE DATACOM APPLICATION NOTE

IP TRAFFIC CARD CABLE CHECK

EVO_AN_019

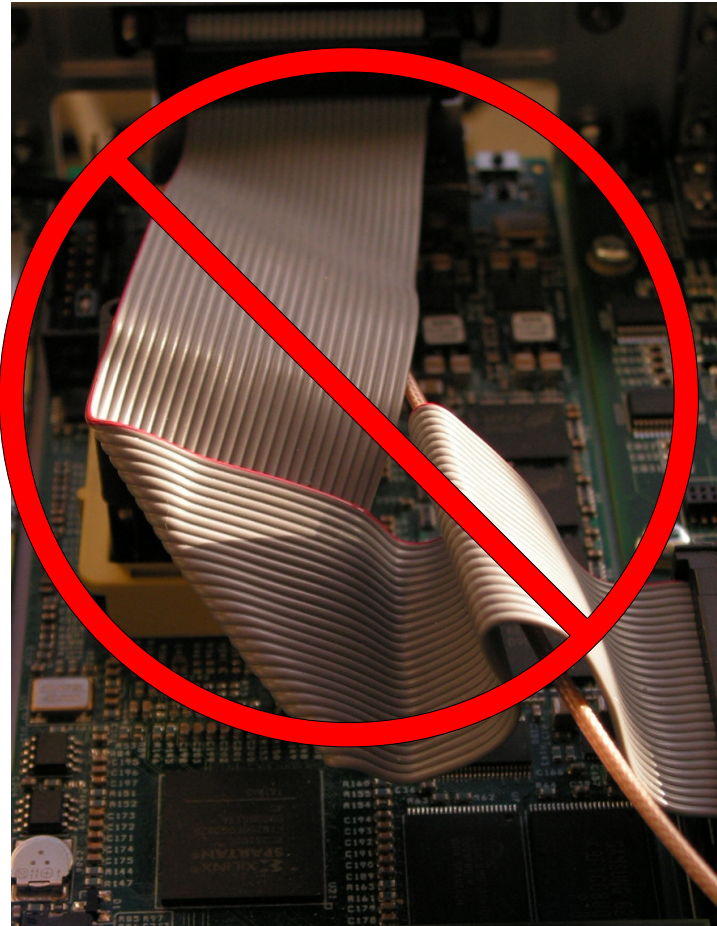
This application note describes how to check the cable routing of the EIA530 cable when an IP Traffic card is fitted. Some cables may be routed incorrectly, inadvertently covering the cooling fan, which may lead to a higher IP Traffic card processor temperature.

Fan obscured – cannot take in air.
This may result in overheating.

With the Modem LCD / keypad facing you the IP Traffic card can be seen at the rear, centre of the Modem. Please check the EIA530 electrical interface cable is not routed over the IP Traffic cards cooling fan, if it does, please remove this cable from the header socket on the Motherboard and re-fold so that when returned to the header socket the cable no longer obscures the cooling fan.

You may need to tape the cable so the folds remain in place.

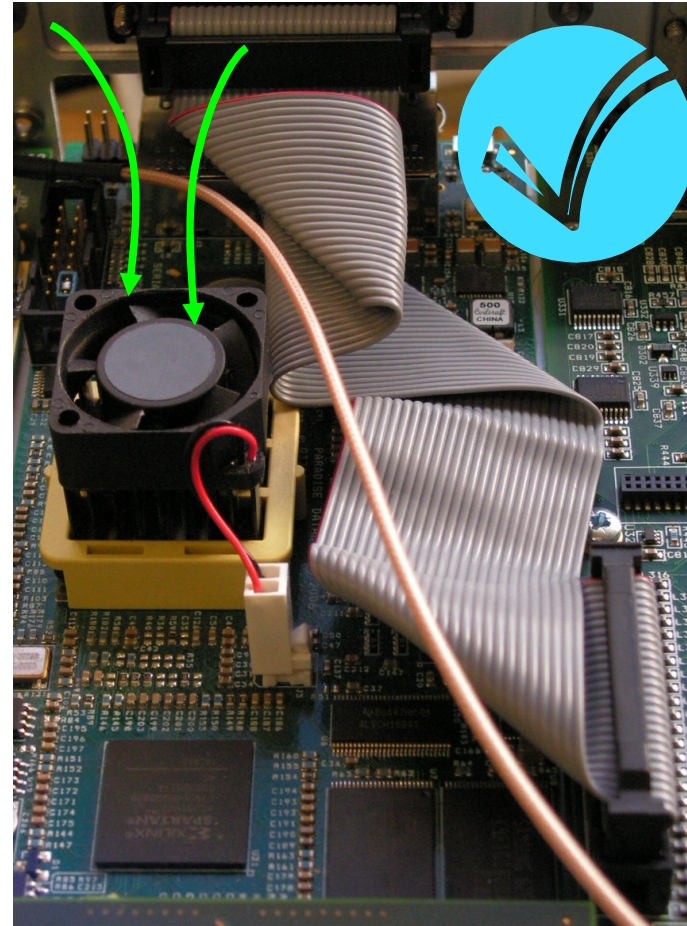
Cable is routed with a few folds away from the fan, can be taped if necessary
Fan is now free to take in air.
